# Preliminary Report on Investigation of Fish Kill in Hamilton Canal

**National Aquatic Resources Research and Development Agency**

**May 2019**

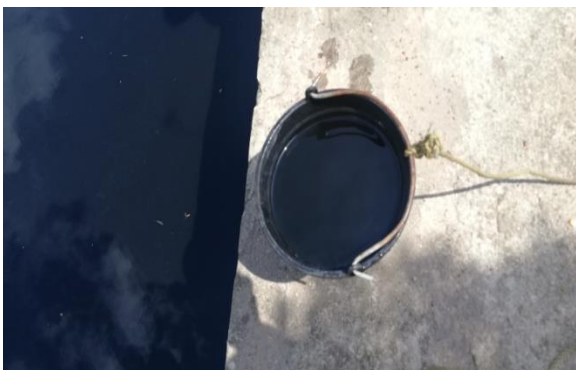
When the time of field investigation, the water level of the Hamilton canal was low nearly up to 2.5 feet depth. Water has become black in colour, contaminated and smelly in the study area (from Elakanda to Pitipana). Dead fish were observed at the edges of the canal and all were belong to the *Oreochromis* spp (Thilapia). Most of the fish were moderate to large in size. Dead fish were decomposed and post-mortem investigations were not possible. Live fish collected were observed under the microscope and any symptom of disease conditions such as scale losses, haemorrhages, lesions, oedema or ulcers were not identified. Gills and internal organs of the fish were in a healthy condition. No nodules, internal haemorrhages or lesions observed and no internal or external parasites were observed to speculate that the mortality is due to any disease condition.

**Figure 4: The water has become dark Black in colour**

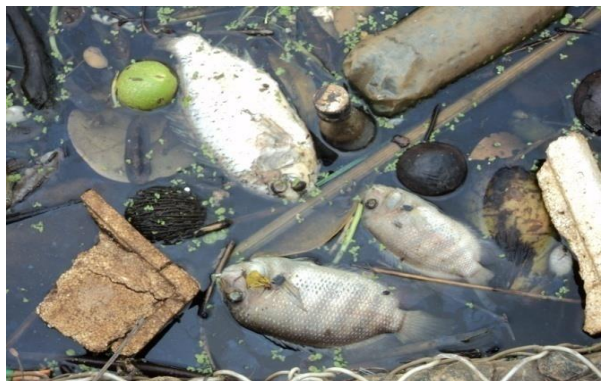
**Figure 5: Dead fish near the canal**

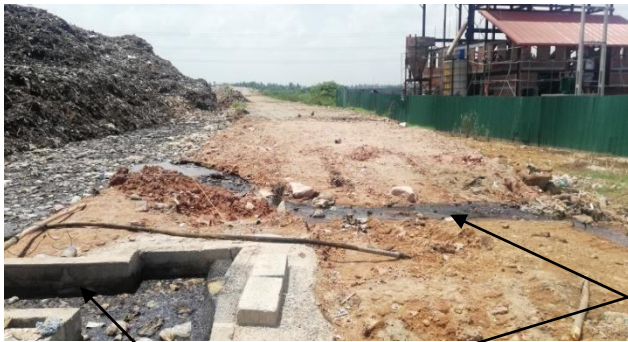
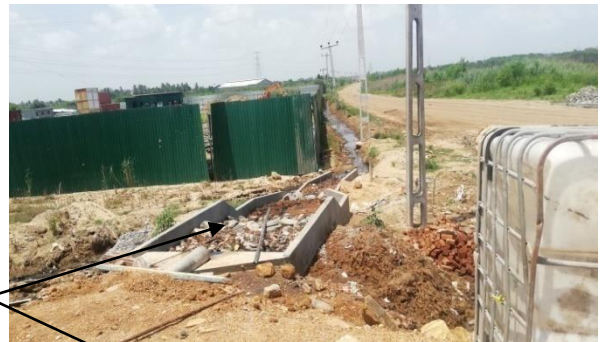
receives only sorted garbage with the total of 750 tonnes with 250 tonnes of degradable garbage. The leachate of the waste dumping site accumulates at the bottom of the landfill and percolates through the soil and overflowing to the canal nearby. There was a leachate filtering system before connect to the canal and it was not working at the time of observation and leachate directly entering to the canal without filtering.

**Figure 6: Leachate filtering system**

connect to the nearby canal without filtering

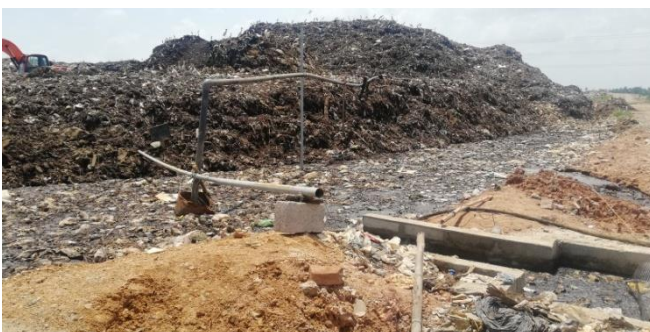
Since it is an open dump area, liners may not be laid underneath to collect toxic leakage and seepage. Therefore, the heavy load of garbage leads to leeching and seepage into groundwater, and secondly, rainwater that comes into contact with garbage may contaminate surface water. The runoff naturally gets into various water bodies, and contaminate them. Furthermore, waste is often compacted and covered with soil.

**Figure 7: Muthurajawela waste dumping site**

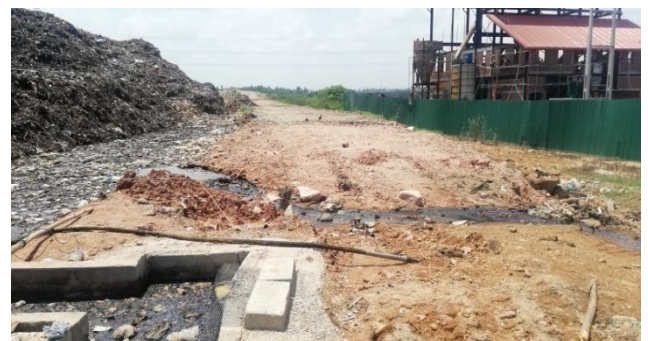
**Figure 8: Leachate from the waste Dumping site**

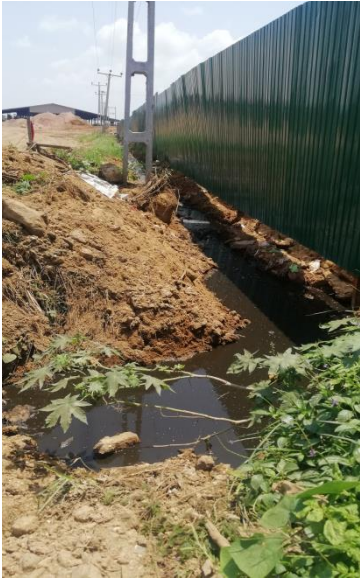
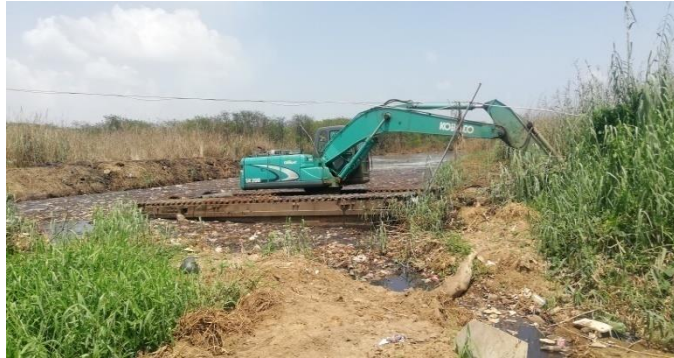
**Figure 9: Canal which connect to the dumping site and stay as stagnant with full of garbage**

The connection of that stagnant water body to the Hamilton canal was unclear and there was no access to observe through that canal to the Hamilton canal. But when the coordinates were plotted to the Google earth map area, it was observed that there is a connection from two sides of the garbage site to the Hamilton canal.

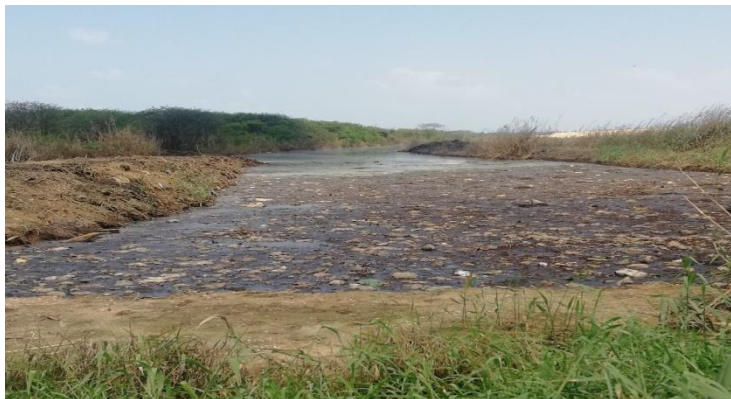
**Figure 10: Sub canal which accumulate the leachate from the dumping site**

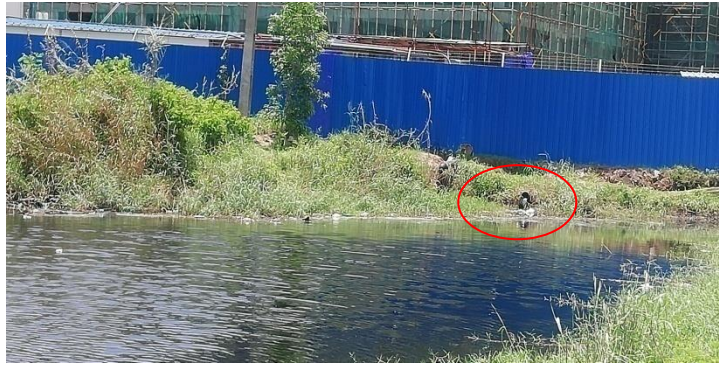
Furthermore, from the site of “Proposed 10 MW Colombo Waste to Energy Project” site, there was a waste water outlet opening to the sub canal of Hamilton canal and the waste water released from the outlet was black in colour.

Figure 11 : Outlet from the “ Proposed 10 MW Colombo Waste to Energy Project” site

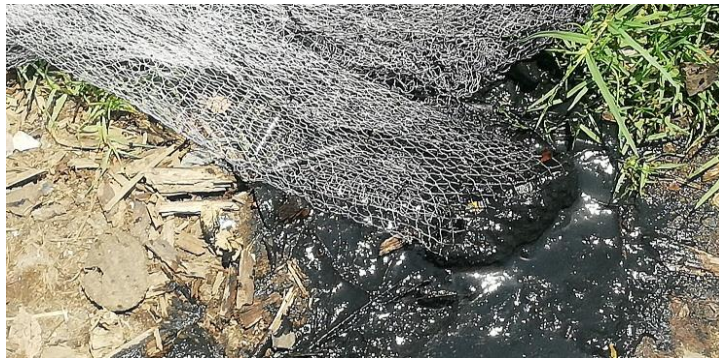
Figure 12: Cast Net with the black colour bottom sediments of the Hamilton Canal
